# REPAIR YOUR PIPES FROM THE INSIDE WITH NUFLOW.

NuFlow is a proven pipe lining technology that restores and renews old, broken or corroded pipes to a "like new" condition without the need to remove or replace them. Our NuDrain cured-in-place pipe lining process does not require any digging or destruction to your property and therefore translates to less mess, less cost, and minimal disruption to your everyday business.

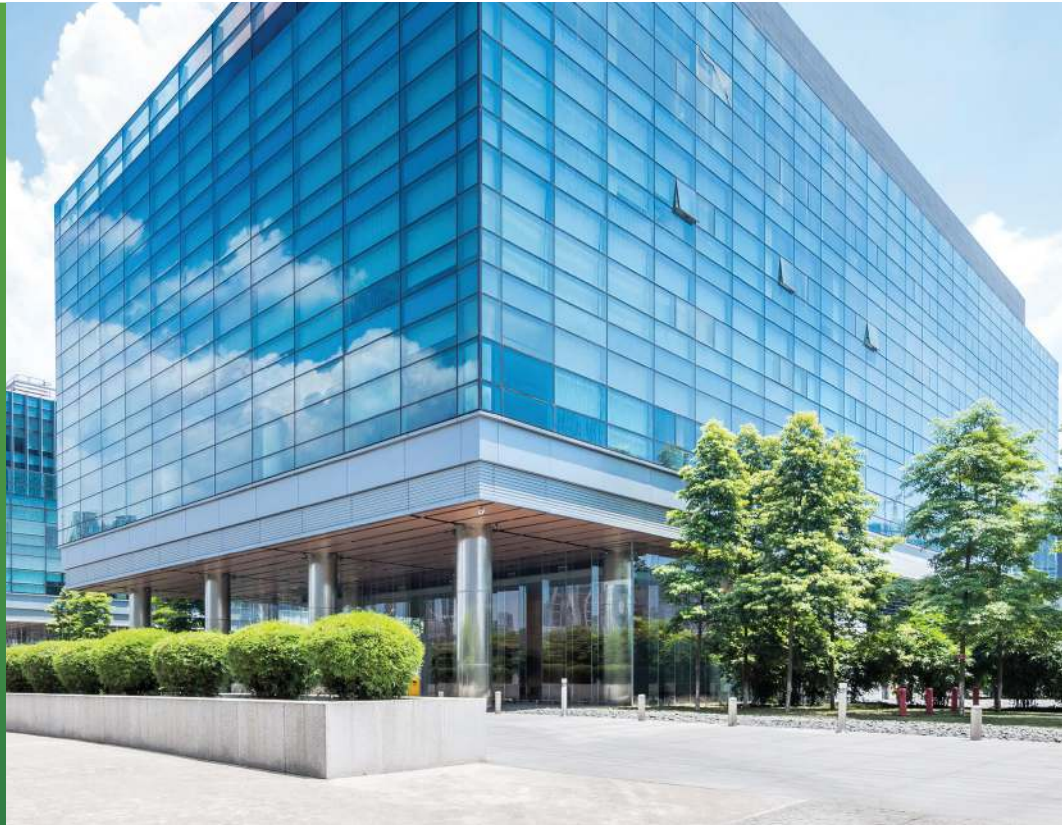
## STEP 1: INSPECTION

Inspect the existing pipes for any corrosion, roots, or cracks using a drain camera.

## STEP 2: CLEANING

Debris, roots and corrosion are removed from the pipes using NuFlow's proprietary tools.

## STEP 3: LINING

NuFlow liner is pulled into the pipe and cures in place, creating a clean, strong "pipe within a pipe". A final inspection is performed for quality assurance.

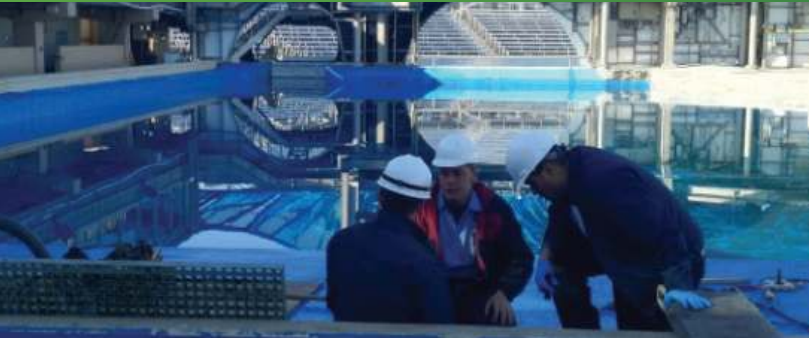
**Southern California Theme Park:  
Underground Drain Line Rehabilitation**

**SITUATION:** 14" to 24" diameter pipes, including a custom 14" by 19" transitional 90-degree elbow, ran beneath large pools, experienced chronic failure. The customer needed a long-term solution that would keep the pool and surrounding landscape intact, as well as cause as little disruption to the theme park as possible.

**SOLUTION:** NuFlow installed our NuDrain structural liner using our unique and innovative pull-in-place technology. This liner will protect the inside of the pipeline and prevent leaks. The customer was so happy with our solution that the company scheduled more work for us to do in that park as well as others across the nation.

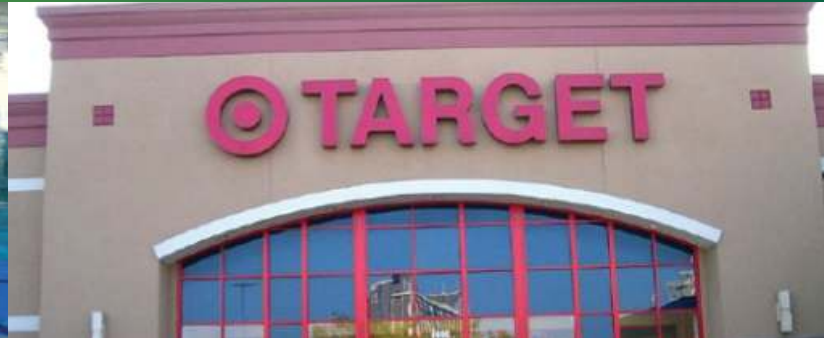
**Target: Underground Sanitary Branch Line  
Rehabilitation**

**SITUATION:** An aged sanitary branch line below the Target's food court experienced backups and limited flow. This pipeline is located beneath the concrete and product displays. The pipeline was jetted years prior, but the problems still returned. The customer wanted a long-term solution that would not disrupt operations.

**SOLUTION:** NuFlow rehabilitated the failing pipe without having to move or unplug any equipment. Our technicians worked while the store was closed at night, and the food court operated normally during business hours. NuFlow's pull-in-place structural liner was installed to prevent future problems.

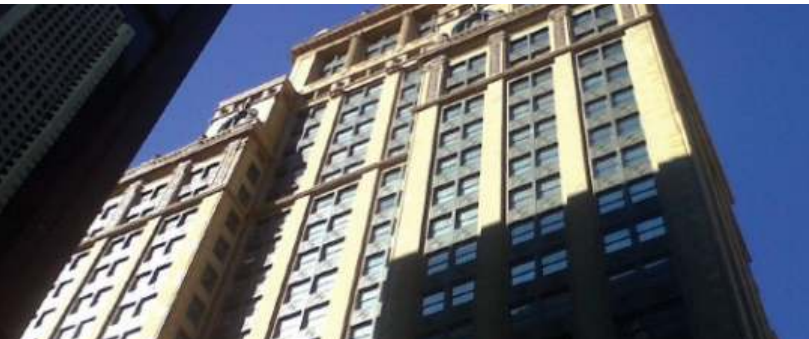
**Temple Emanu-El:  
Roof Drain System Rehabilitation**

**SITUATION:** The 10 roof drains encased in concrete pillars were rotten, had leaks and could have destroyed the historical temple from within. The roof drains run through 12-story columns in the middle of the synagogue.

**SOLUTION:** NuFlow's trenchless technology preserved the historic temple and the interior columns, causing minimal disruption to the temple's normal operations. NuFlow's pull-in-place structural liner created a new pipe within the existing host pipes, protecting the drain system from future problems.

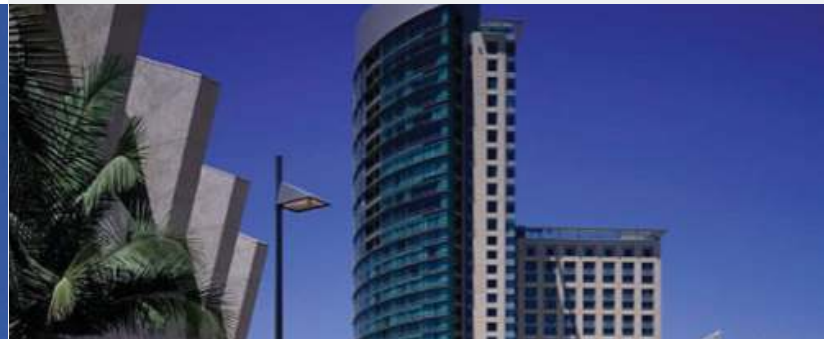
**Omni Hotel: Sewer Drain Line Rehabilitation**

**SITUATION:** The waterfront hotel sits at sea level, with its parking structure below the hotel. Beneath an 18" slab, the hotel's sanitary drain line runs below the ocean's water table. The corrosive ocean water ate away at a 70 foot run of 4" cast iron pipe, leaving a large channel missing from the bottom of the pipe.

**SOLUTION:** After a traditional spot repair by another company failed, the hotel hired NuFlow to install our pull-in-place, seamless liner into the drain system. Our no-dig technology did not cause unsightly construction, and the retrofit liner will protect the pipes from the ocean water.
