REPAIR YOUR PIPES FROM THE INSIDE WITH NUFLOW.

Regional Municipality of Durham: Lateral Drain Rehabilitation

Maryland House of Delegates: Roof Drains Rehabilitation

Toronto Pearson International Airport: Elevator Shaft Drain Line Rehabilitation

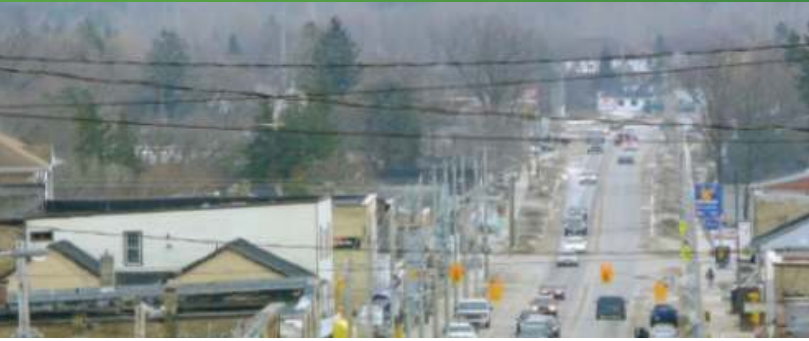
SITUATION: Lateral pipes were experiencing blockage and failure due to root intrusions, cracks, corrosion, and failing joints. The typical lateral pipes range from 4" to 6" in diameter and some pipes run up to 120 feet long.

SOLUTION: NuFlow installed more than 10,000 feet of structural liner to residential, commercial, and industrial properties in the Durham Region. NuFlow's pull-in-place liners rehabilitated the pipes preventing corrosion, blockage, and leaks from occurring in the future.

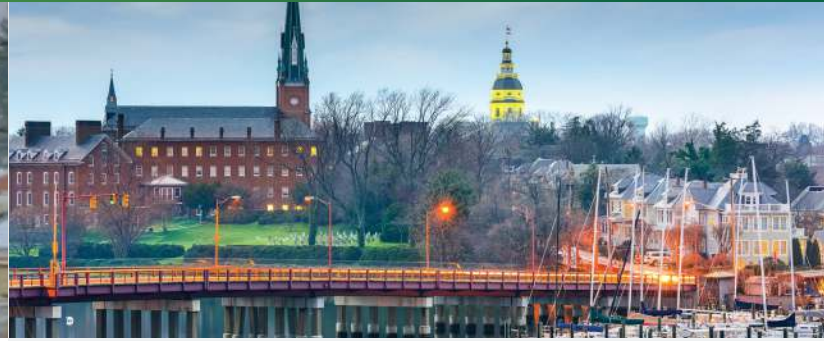
SITUATION: The Maryland House of Delegates' office building had leaking roof drains and a failing HVAC pipe system. The roof drains were cracked and breached which allowed water to get into the building during rain and snowfall.

SOLUTION: NuFlow was able to effectively rehabilitate the roof drains and HVAC pipe systems without destroying the building and without disrupting the other contractors' work. NuFlow successfully cleaned and lined the aged and leaking roof drains with our patented NuDrain pull-in-place structural liner, which covered up all leaks and will prevent future problems from occurring.

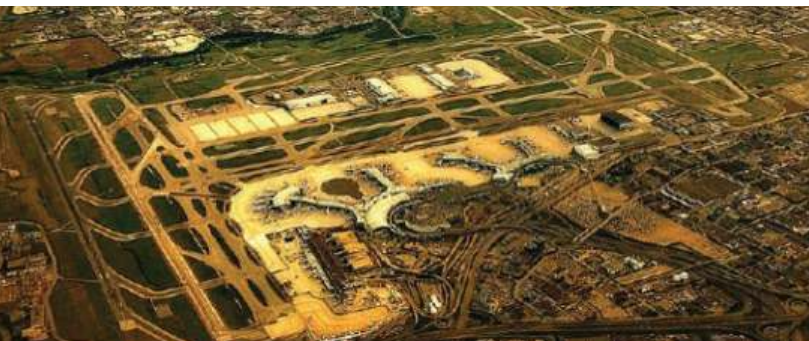
SITUATION: A 3" cast iron drain line, used to drain the elevator shaft from hydraulic oil and other fluids, was filling with rainwater. The drain line is located 5 feet under concrete.

SOLUTION: CCTV investigation revealed that two joints in the pipe were allowing infiltration. NuFlow's pull-in-place structural liner was installed to seal and protect the pipe. The liner cured overnight, and the installation process did not disrupt the airport's operations.

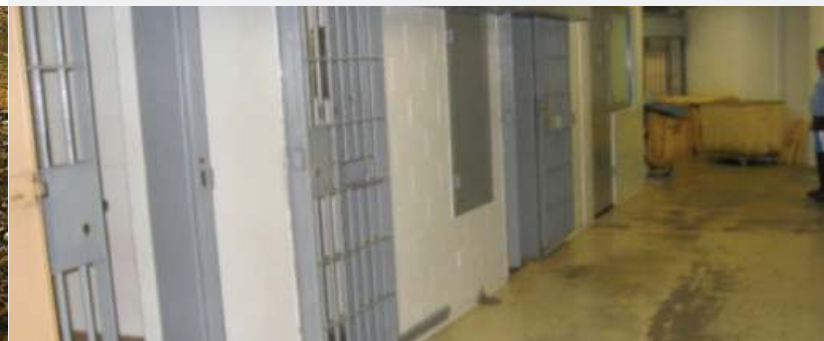
Lee County Jail: Sanitary Drain System Rehabilitation

SITUATION: 4", 6", and 8" diameter cast iron sewer drain pipes under the slabs in half of the 5-story jail were corroded, causing back-ups and limited water flow.

SOLUTION: Digging through the foundation was not an option because the facility had to have the sanitary system operational and the jail was at 94% capacity with no room to move the inmates. NuFlow's patented pull-in-place structural liner was inserted without destruction or disruption.
