REPAIR YOUR PIPES FROM THE INSIDE WITH NUFLOW.

**Annheuser-Busch Brewery:
Sanitary Sewer Rehabilitation**

**Kewaunee Nuclear Power Plant:
Underground Drain Rehabilitation**

**General Atomics:
Sanitary Drain Line System Rehabilitation**

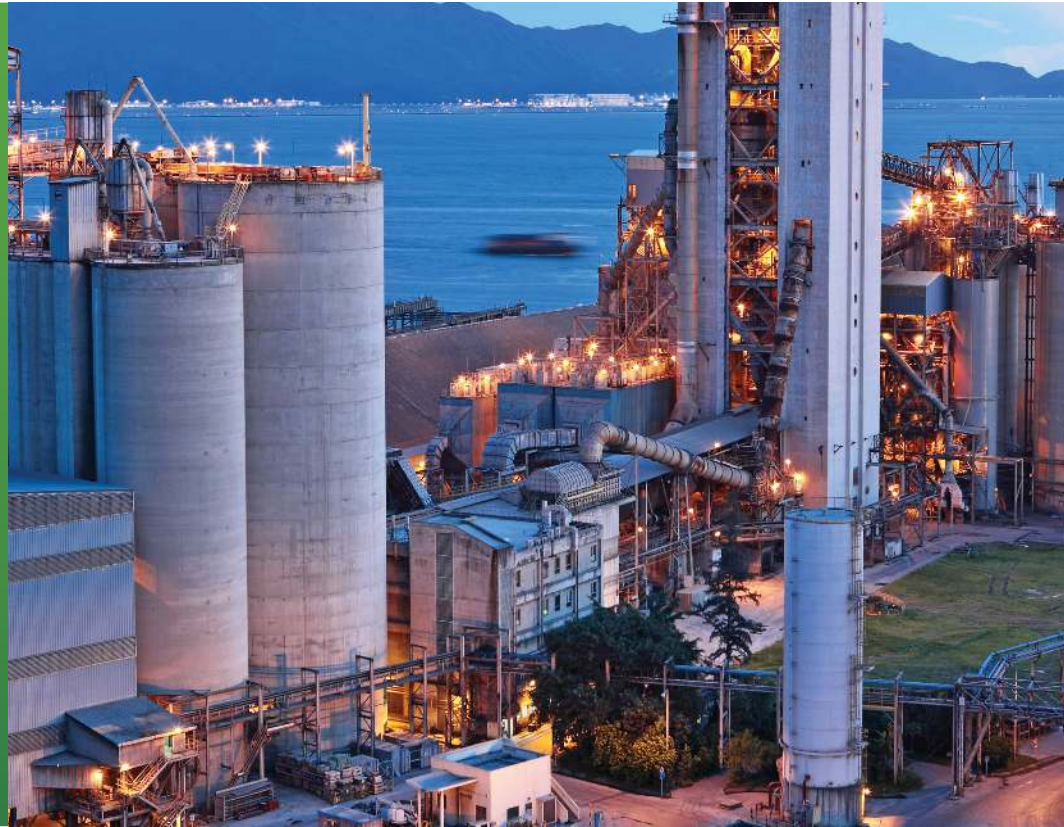
STEP 1: INSPECTION

Inspect the existing pipes for any corrosion, roots, or cracks using a drain camera.

STEP 2: CLEANING

Debris, roots and corrosion are removed from the pipes using NuFlow's proprietary tools.

STEP 3: LINING

NuFlow liner is pulled into the pipe and cures in place, creating a clean, strong "pipe within a pipe". A final inspection is performed for quality assurance.

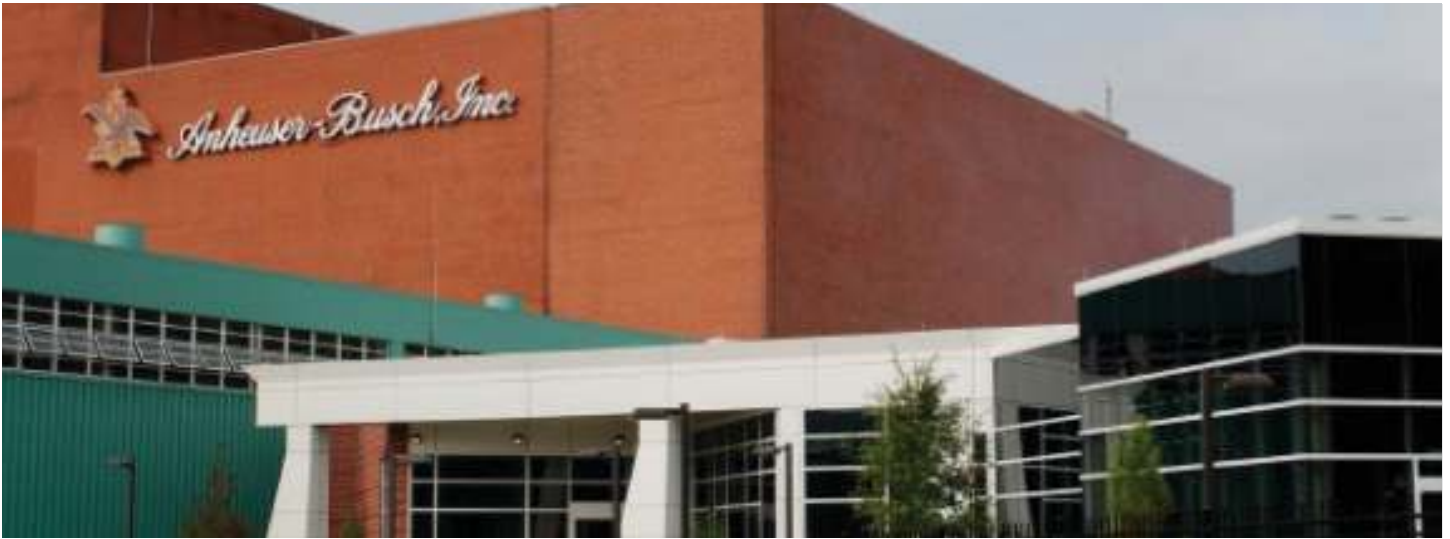
SITUATION: 200 feet of 8" cast iron sanitary sewer line was failing. The sanitary system was located deep under floors, foundations and inside walls. The customer needed a long-term solution.

SOLUTION: Working with general contractor ESGI, NuFlow was able to rehabilitate the pipe system using our NuDrain structural lining, saving the customer the destructive, time-consuming and costly option of a re-pipe.

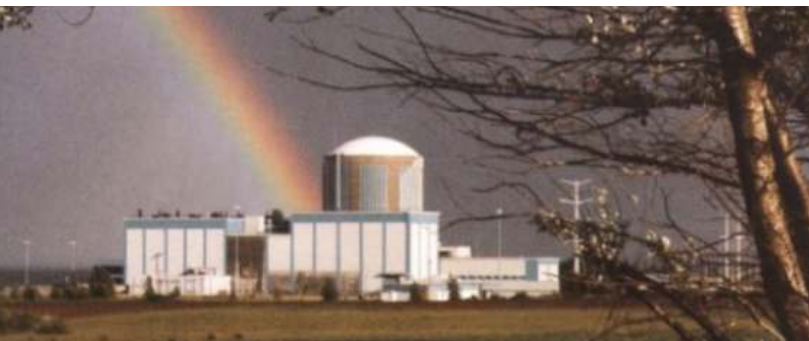
SITUATION: Part of a 6" diameter drainpipe encased in concrete was leaking 10 feet under a concrete structure. Breaking through the concrete to access the pipe was not an option.

SOLUTION: NuFlow rehabilitated the leaking pipe with our NuDrain pull-in-place structural liner and created a seamless pipe inside the host pipe without disrupting the plant's normal operations. NuFlow contracted a scuba diver to work the discharge point below the waterline in Lake Michigan.

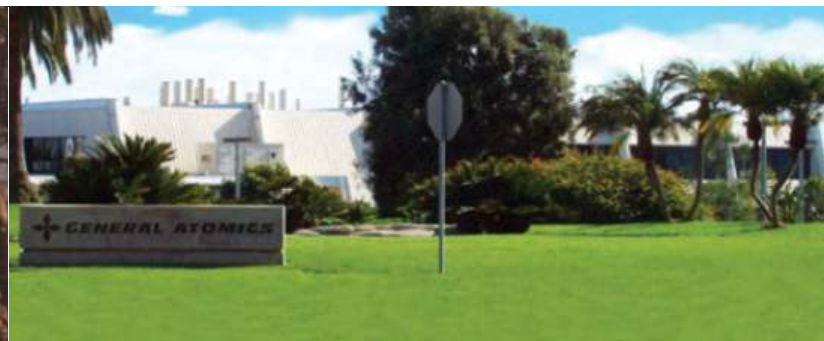
SITUATION: Sanitary drain line experienced backups and reduced water flow because of cracking, root intrusions and weakened joints. The system consists of 6" clay pipe connected to 4" PVC pipe, beneath a layer of asphalt.

SOLUTION: The pipe is below an entrance to the building, so NuFlow's trenchless technology prevented disruption to the office's normal operations. NuFlow cleaned the pipe system, restoring flow, and then installed our NuDrain structural liner to prevent future problems.
