# REPAIR YOUR PIPES FROM THE INSIDE WITH NUFLOW.

### Hidden Valley Home: Underground Drain Line Rehabilitation

### Christian Care Communities: Vertical Drain Stacks Rehabilitation

### Las Flores Tower Condominium: Drain and Potable Rehabilitation

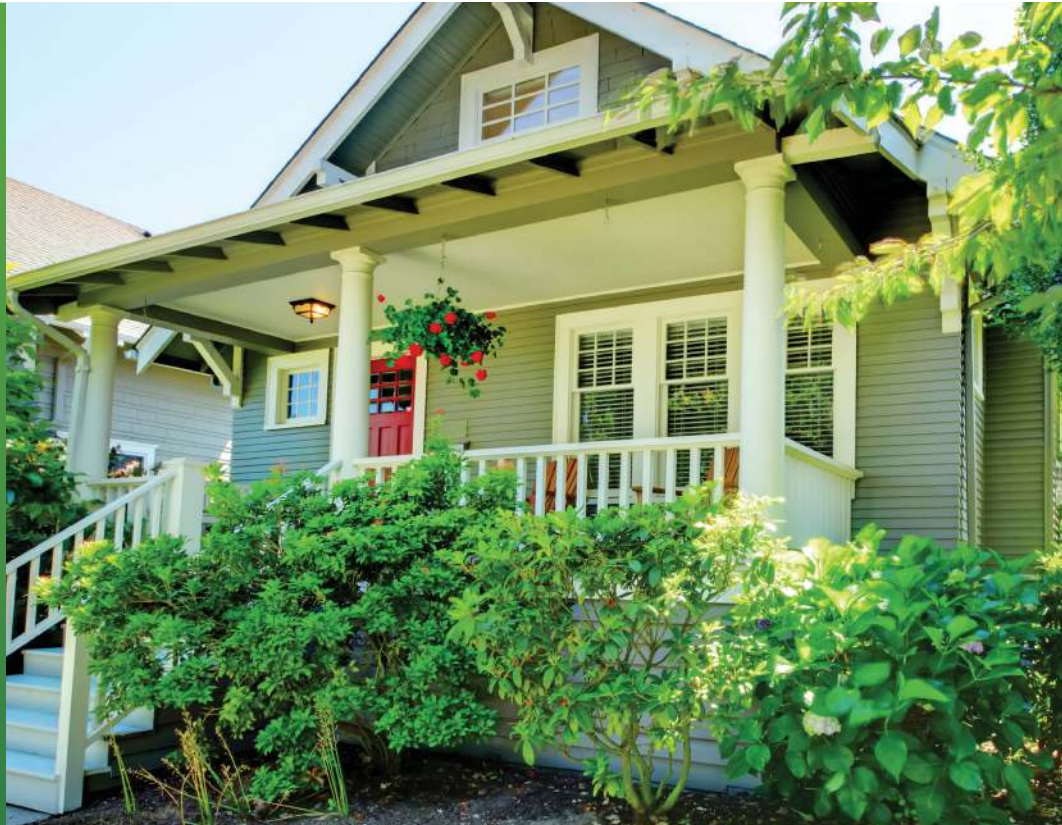
## STEP 1: INSPECTION

Inspect the existing pipes for any corrosion, roots, or cracks using a drain camera.

## STEP 2: CLEANING

Debris, roots and corrosion are removed from the pipes using NuFlow's proprietary tools.

## STEP 3: LINING

NuFlow liner is pulled into the pipe and cures in place, creating a clean, strong "pipe within a pipe". A final inspection is performed for quality assurance.

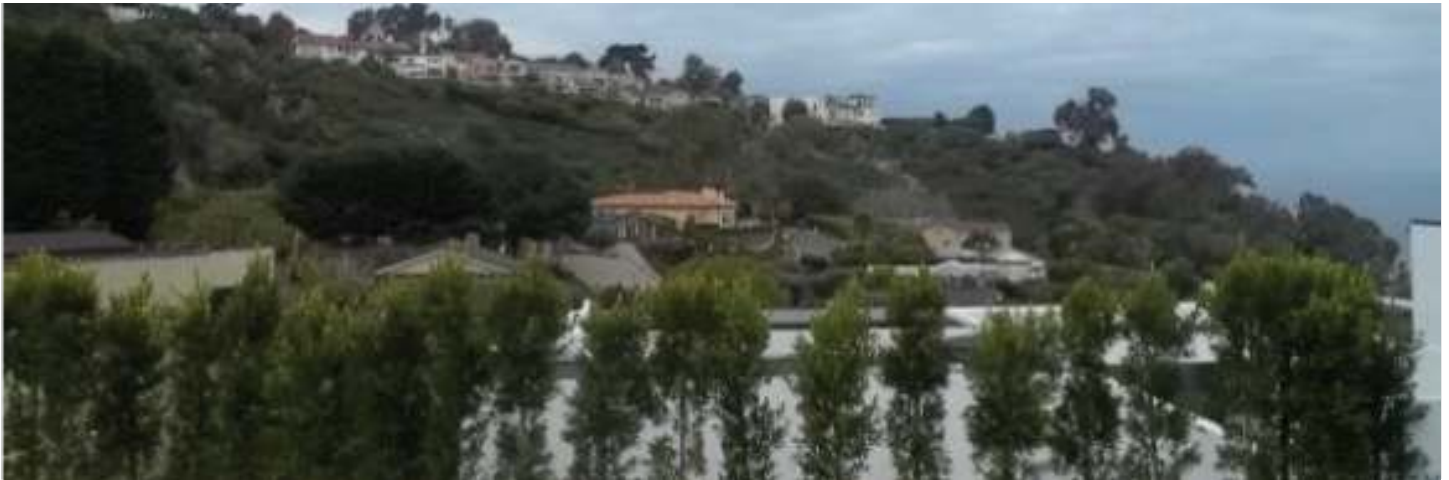
**SITUATION:** The customer's sanitary system experienced chronic backups due to heavy root intrusion in the pipeline. This 4" clay sewer pipeline runs 6 to 9 feet underneath hilly terrain from the home's yard and through his neighbor's yard. The customer wanted a no-dig solution to preserve the yards.

**SOLUTION:** NuFlow successfully cleaned and lined this underground drain line without having to dig up any yard. After the blocked sanitary line was cleaned and reinstated, our pull-in-place liner was installed using existing access points. This structural liner forms a new, protective pipe that will prevent future failures.

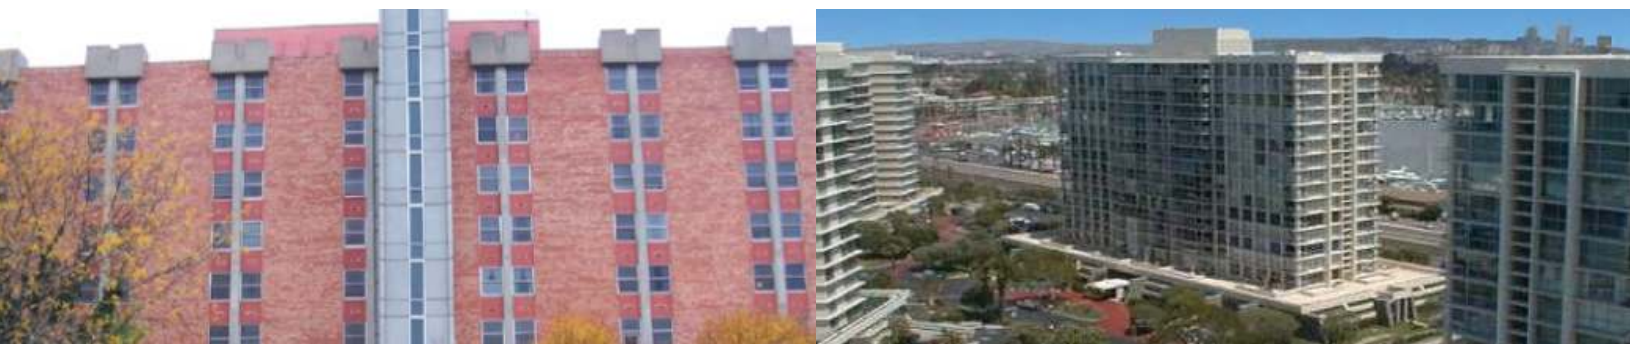
**SITUATION:** Vertical drain stacks were clogged in the 10-story apartment building and leaking because of grease buildup. The system consists of 21 stacks with cast iron pipes 100 feet long and 3" in diameter.

**SOLUTION:** NuFlow was able to retrofit 10 floors at a time without having to relocate any residents or cause any destruction to the building. The drain stacks are now free of corrosion, buildup and pinhole leaks.
